Research
Paper
FPL 444

Longtime Performance of Trussed Rafters with Different Connection Systems

Thomas Lee Wilkinson

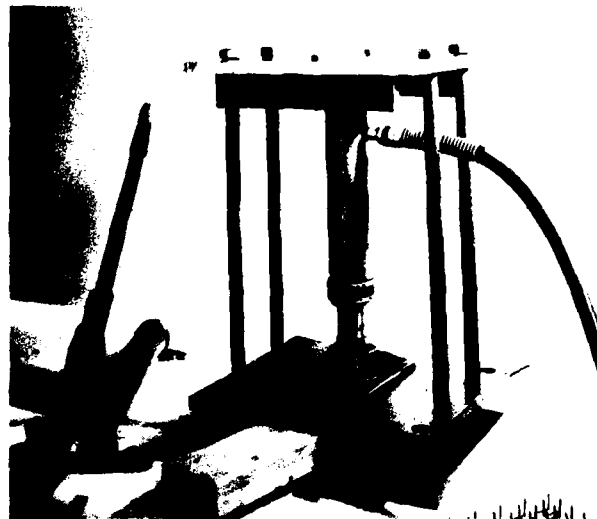
Figure 8.—Portable hydraulic jacking system used to apply toothed and barbed metal plates. (M132794)

The trussed rafters were carefully assembled in the Forest Products Laboratory shop. The barbed and toothed metal plates were applied with a portable hydraulic jack (fig. 8). Plates were applied to one side of the trussed rafter; then it was turned over and plates applied to the opposite side. For the nail-glued trusses, gussets were applied to one side and allowed to set for at least 3 hours. They were then turned over and gussets applied to the other side. Room temperature during the gluing was $78^{\circ} \pm 4^{\circ}\text{F}$.

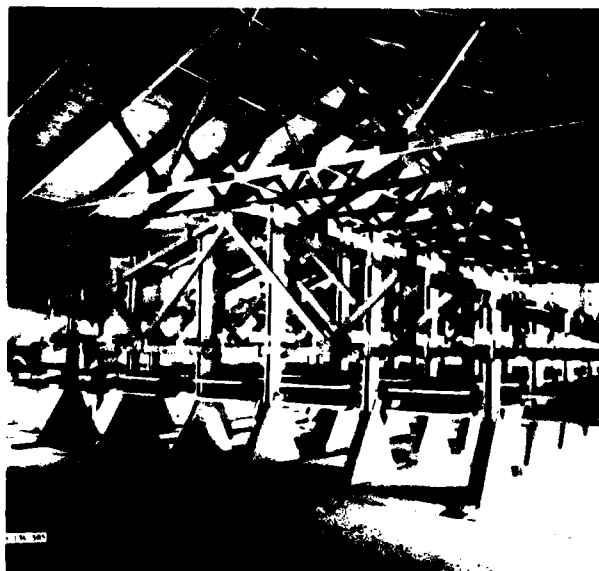
Figure 10.—Experimental arrangement for dead-loading of trussed rafters. Loads were suspended at 2-foot intervals along the chords. (M134585)

The loaded trusses are shown in figure 10. Each trussed rafter was supported and loaded independently. A load of 20 pounds per foot (design dead load of 10 lb/ft² for a 2-ft spacing) was applied to the lower chords, and a load of 36 pounds per foot (design dead load plus half of the design live load) was applied to the upper chords. This load represented the expected truss load during its service life. Weights were carried by cables attached to the chords at 2-foot intervals. The trussed rafters were supported on 4-1/2-inch-wide bearing areas. Load span was 28 feet from outside to outside of supports.

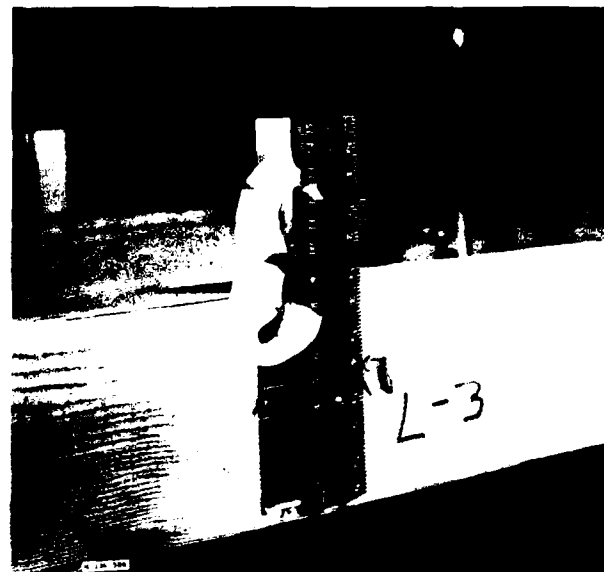
Figure 11.—Scale, mirror, and line arrangement used for measuring deflection. (M143586)

The deformed shape of the chord members was determined from deflection readings taken at 2-foot intervals along the upper and lower chords. A scale and mirror fastened at each point, and a taut line (fig. 11) were used to read the deflections. Sighting the line so that it covered its image in the mirror eliminated parallax errors. The scale was read where the line crossed. The line was stretched over pins located at the intersections of the centerlines of the upper and lower chords, which were about 1 inch outside the edge of the bearing area. The line for the upper chords was also stretched over a pin located at the centerline of upper chords at the peak. The relative movement between a scale suspended from this pin and the taut line along the lower chord gave the vertical movement of the peak.

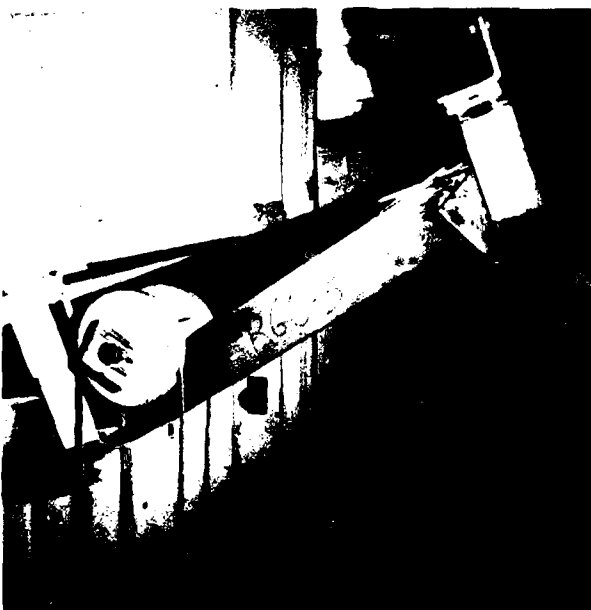
Figure 22.—Typical failure of trussed rafter in upper chord over compression member. (M140589-1)

Most failures (21 of 28) occurred in bending in the upper chords as shown in figures 21 and 22. Other modes of failure were by failure of the joints (figs. 23, 24, 25, and 26) and by tension in the lower chord (fig. 27).
